ENERGY ENGINEERING ANALYSIS PROGRAM (EEAP)

ENERGY SAVINGS OPPORTUNITY SURVEY FORT WAINWRIGHT, ALASKA

Volume I: Executive Summary

Department of the Army Corps of Engineers, Alaska District Anchorage, Alaska

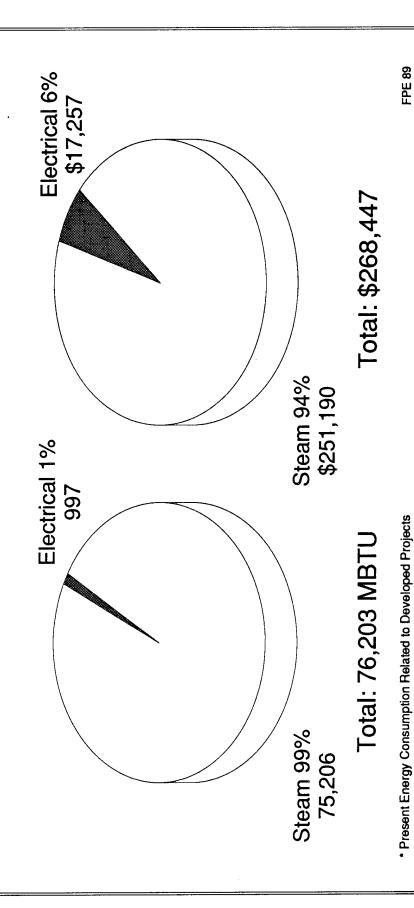
FIGURE 1

Figure 1, Present Energy Use, summarizes the energy consumption associated with developed ECOs. When reviewing the values of energy consumed, the reader is reminded that the work reported upon herein was focused on specific, energy consuming **building systems**, as contrasted with total energy consumed by the facility under study. For example, when analyzing the advisability of insulating steam piping, the analysis was focused on calculation of energy wasted to the surroundings before and after the steam pipe was insulated. Since the heat transmitted from the steam source to the steam appliance, through the steam pipe, was assumed to be unaffected by application of the ECO, transmitted heat is not accounted for in the analysis, nor is it reported herein.

Present Annual Energy Use* Fort Wainwright

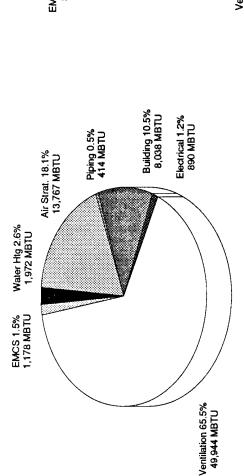
FIGURE 2

This consideration is also important when examining energy consumption by system as in Table 3 and Figure 2. Table 3 lists the present energy consumption of systems for which ECOs were developed. In presenting this information here, ECOs dealing with similar systems have been grouped together, e.g., those dealing with building insulation are accumulated under Building Envelope, while those dealing with various HVAC systems controls have been totaled as Mechanical Air Systems. Figure 2 graphically presents this data for each type of system as a percentage of the total.

Present Annual Energy Use By System*

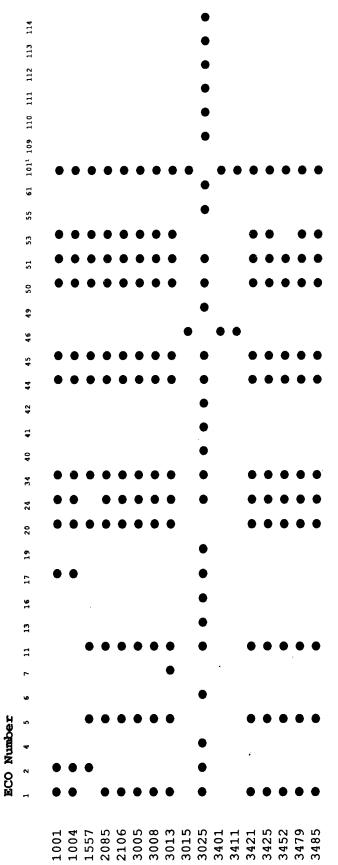
TABLE 4 Investigated ECOs Summary Fort Wainwright

Table 4, Investigated ECOs, correlates the buildings to each ECO investigated. Following that Table is a descriptive listing which provides summary definitions of each ECO.

ECO 101: For buildings in which ECO 20, 34 or 44 has been analyzed, the related portion of ECO 101 will not appear as a separate analysis. Note: 1.

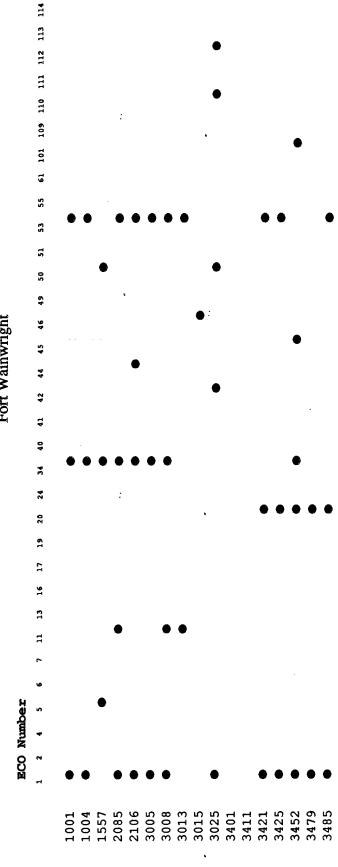
TABLE 5
Recommended ECOs Summary
Fort Wainwright

Table 5, Recommended ECOs, correlates individual buildings to recommended ECOs. Table 6 provides supplemental information in the form a listing of the ECO number and name, building number and name, Savings to Investment Ratio (SIR), Simple Payback (SP) and Construction Working Estimate (CWE) as of the analysis base year of FY87, all ranked according to decreasing SIR. As in the case of investigated ECOs, more ECOs are recommended in Table 6 than are indicated in Table 5 due to additional sub-sets of ECOs.

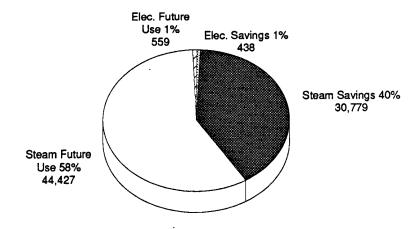
Developed Projects Annual Energy Savings
Fort Wainwright

Total Savings : 31,217 MBTU/Year Total Future Use: 44,986 MBTU/Year

Figures 5 through 10 graphically illustrate the energy and associated costs presently being used and the savings accountable to each developed project package.

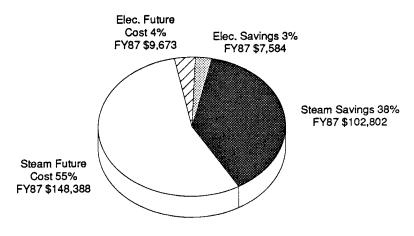
Developed Projects Annual Cost Savings
Fort Wainwright

Total Savings : \$110,386/Year (FY 1987) Total Future Cost: \$158,061/Year (FY 1987)

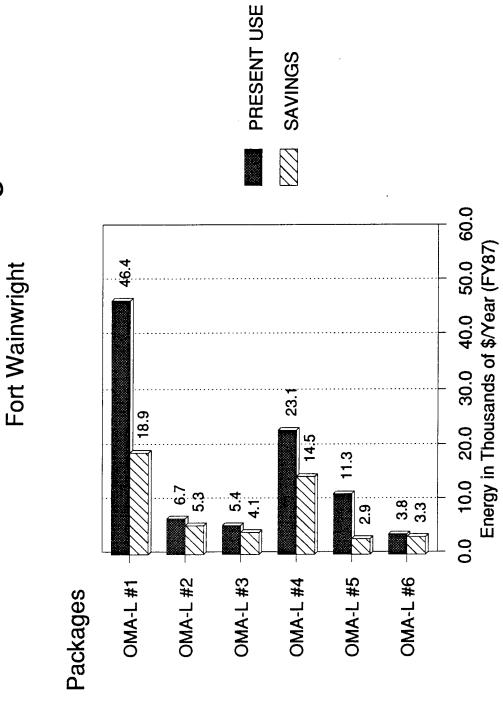
OMA-L Funded Packages

Total Energy Savings: 13,542 MBTU/Year

Energy in Thousands of MBTU/Year

Total Energy Cost Savings: \$48,905/Year (FY 1987)
